Trek Bed Motor Replacement – 2004 Trek
By Ralph Cerney
E-mail: h53@aol.com

I've recently replaced the motor on my 2004 Trek bed. I want to send along some info to anyone who wondered what the bed and motor assembly looks like when all the façade is removed and a basic course on how to replace the motor. I have the classic kitchen coach with the bed in the front over the living room.

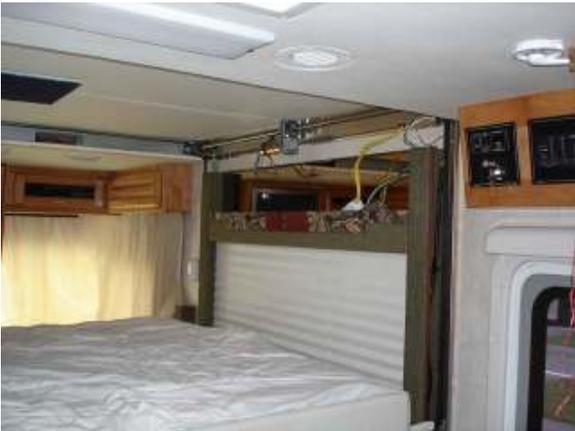
Trek Bed Curb side Overview

The pictures illustrate the curb and street side mechanisms. Running the length of the bed on the curb side, at the ceiling and behind a valance, are a motor located in the middle with two shafts running from the motor to the edge of the bed assembly. The shafts are attached by bolts to the motor drive assembly and rest in a bearing assembly at the ends of the wall at the ceiling. The pictures clearly show the assembly.

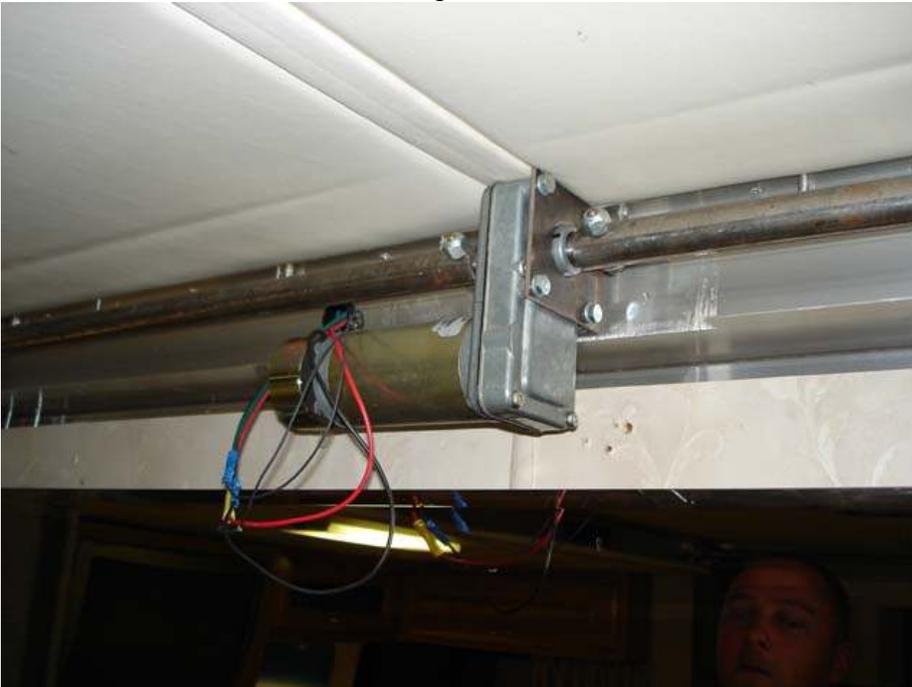
Trek Bed Curbside Motor Close up

First remove the bolts that attach the two shafts to the motor gearbox. Don't attempt to remove the motor from the wall bracket at the wall mounting point. Those six bolts are impossible to reach at this point and there is no reason to remove them. You will be removing the motor from that bracket at the motor gearbox by four easily accessible bolts. Now is the time to remove those four bolts.

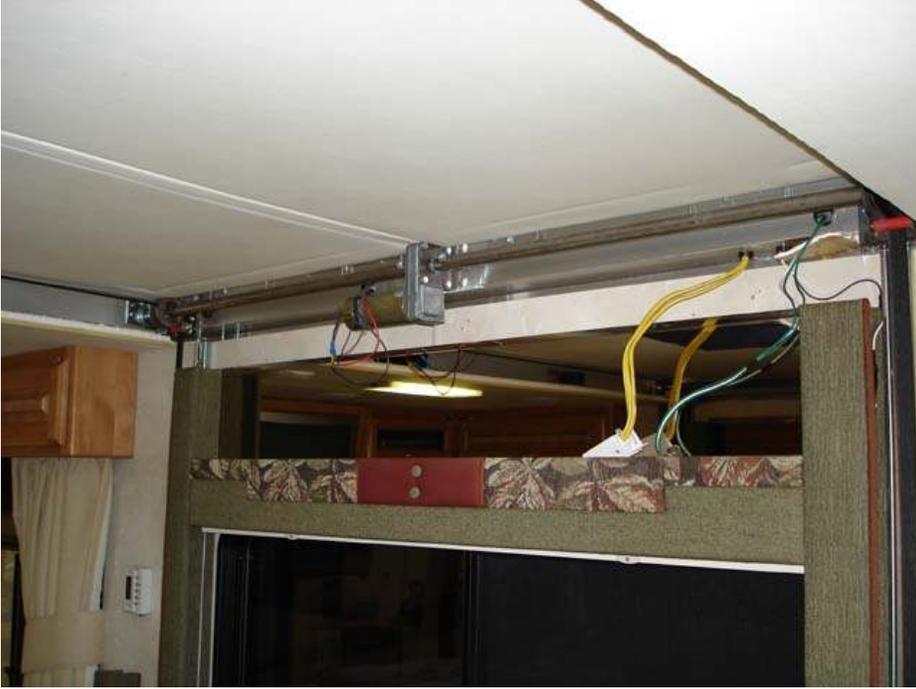
Trek Bed Curb side

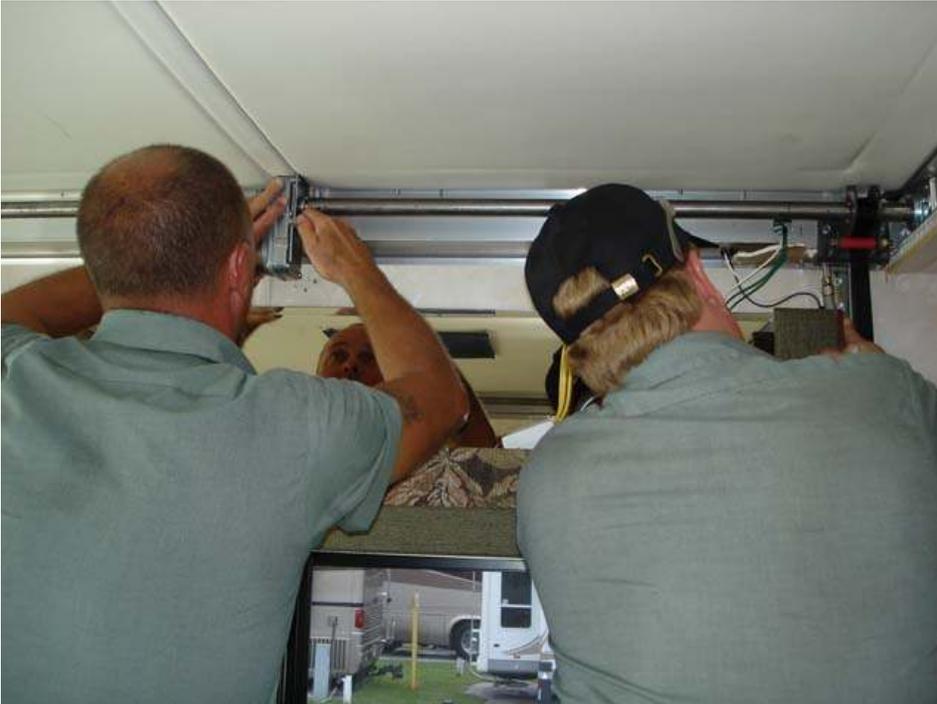
Trek Bed Curb side Reinstall Motor & Shaft

After replacing the motor, just reverse the entire process to put it all back together. Ensure your belts are not twisted and take up the belt slack when you reattach the shafts to the motor.

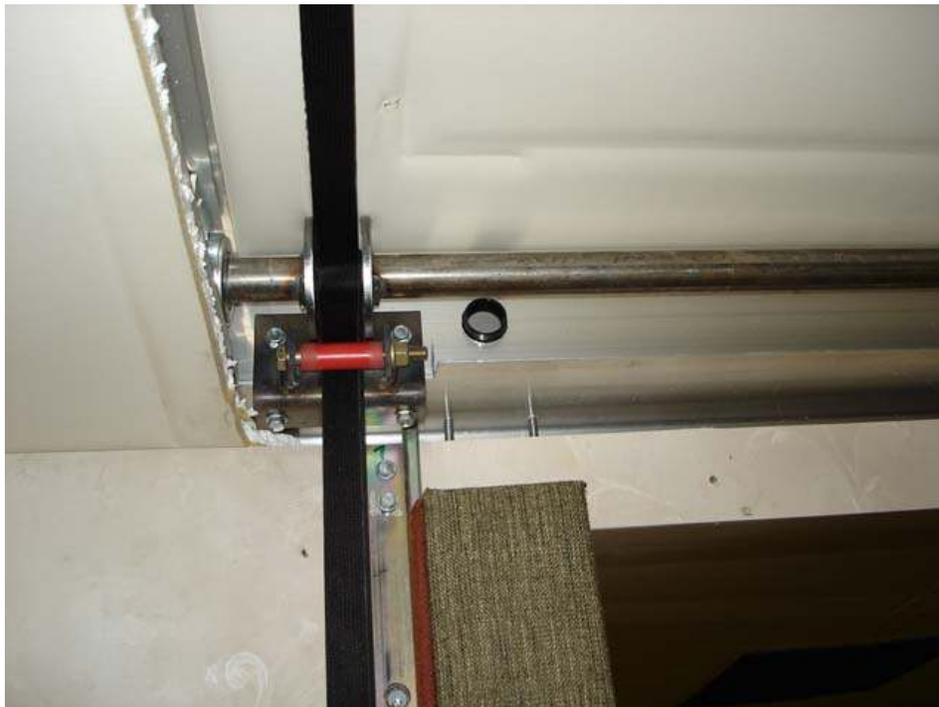
Trek Bed Curb side Front Roller

At the end of the shafts that span from the motor to the wall are a bracket roller assembly and a bearing assembly. These must both be unbolted to continue the process. Once free, the roller assembly bracket can be slid down the belt and rested on top of the inner valance. **Be careful not to twist the belts.** Once the bearing assembly is free it now gets difficult. A split shaft would have helped immensely, but the engineers didn't go that route so now you have to remove the shaft from the motor using brute force and finesse. The motor will be free to "wiggle" and the shafts will have "some" fore and aft play, but not enough to be removed from the motor gearbox. The techs that did my coach slid the bearing end of the shaft towards the middle of the coach until the shaft had enough clearance to come off the motor gearbox assembly. It was a difficult process with care taken not to bend the shaft or break the motor gearbox assembly. I wish there was an easier way, but they and I didn't see one. I think the roof to the coach was assembled at the factory after the bed assembly was installed, so it's tough to access this area now.

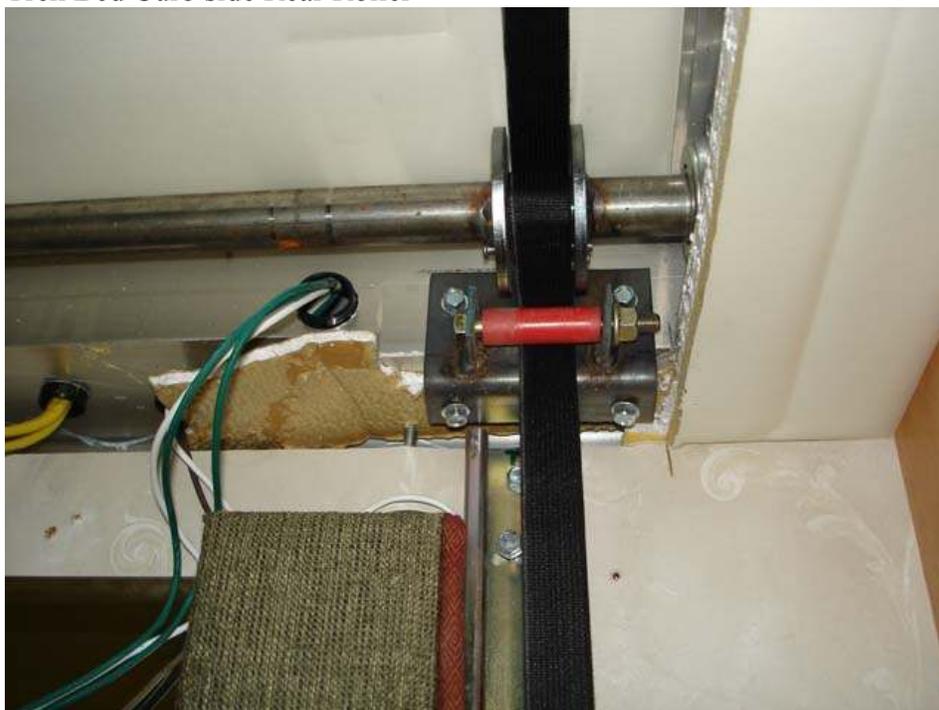
Trek Bed Curb side Rear Roller

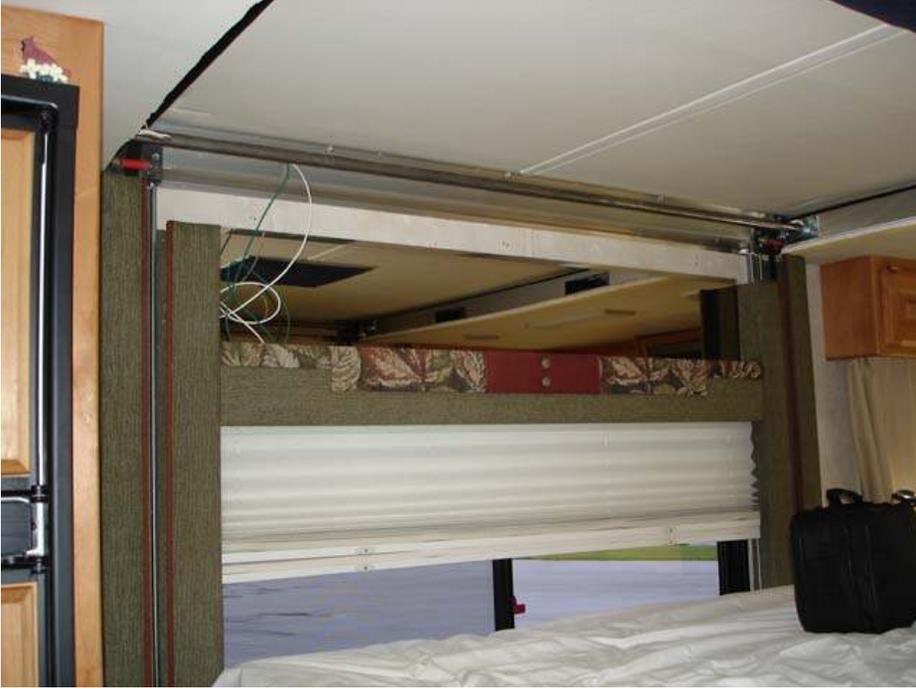
Trek Bed Driver side Overview

There are four attachment points for the belt system of the bed, two on the curb side and two on the street side. On the street side, the belts merely move over a roller and shaft as the bed moves up and down. The action area for the bed system is located on the curb side which includes the motor assembly and belt take up pulleys. The take up pulleys are used to take up and store the belt when the bed is raised
